# Preliminary Site (Contamination) Investigation - National Research Cyclotron Facility

Document no: IS530900  
Revision: 3

Australian Nuclear Science and Technology Organisation  
ATM Number: PSC00217

**Project name:** Camperdown PSI

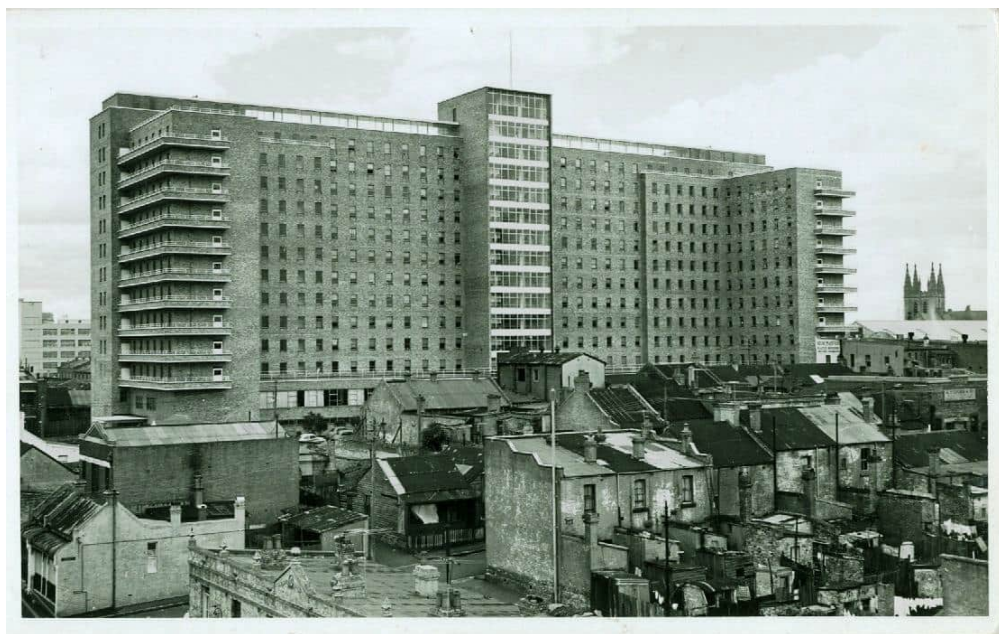
**Photo 1. Queen Mary Nurses Home in 1960 (RPA Museum, undated)**

As noted in Section 2.3, the Site is part of the RPA Hospital campus. RPA Hospital was first developed in 1868 from undeveloped or agricultural land owned by the University of Sydney (Dunn, M. 2008). The initial development of the hospital was on the eastern side of Missenden Road. The Queen Mary building was constructed as a nurses home in 1956 on the western side of Missenden Road, just west of the Site. An image from the RPA Museum website of the Queen Mary building in 1960 is provided below (RPA Museum, undated). The image shows residential and mixed use buildings to the south of the Queen Mary building.

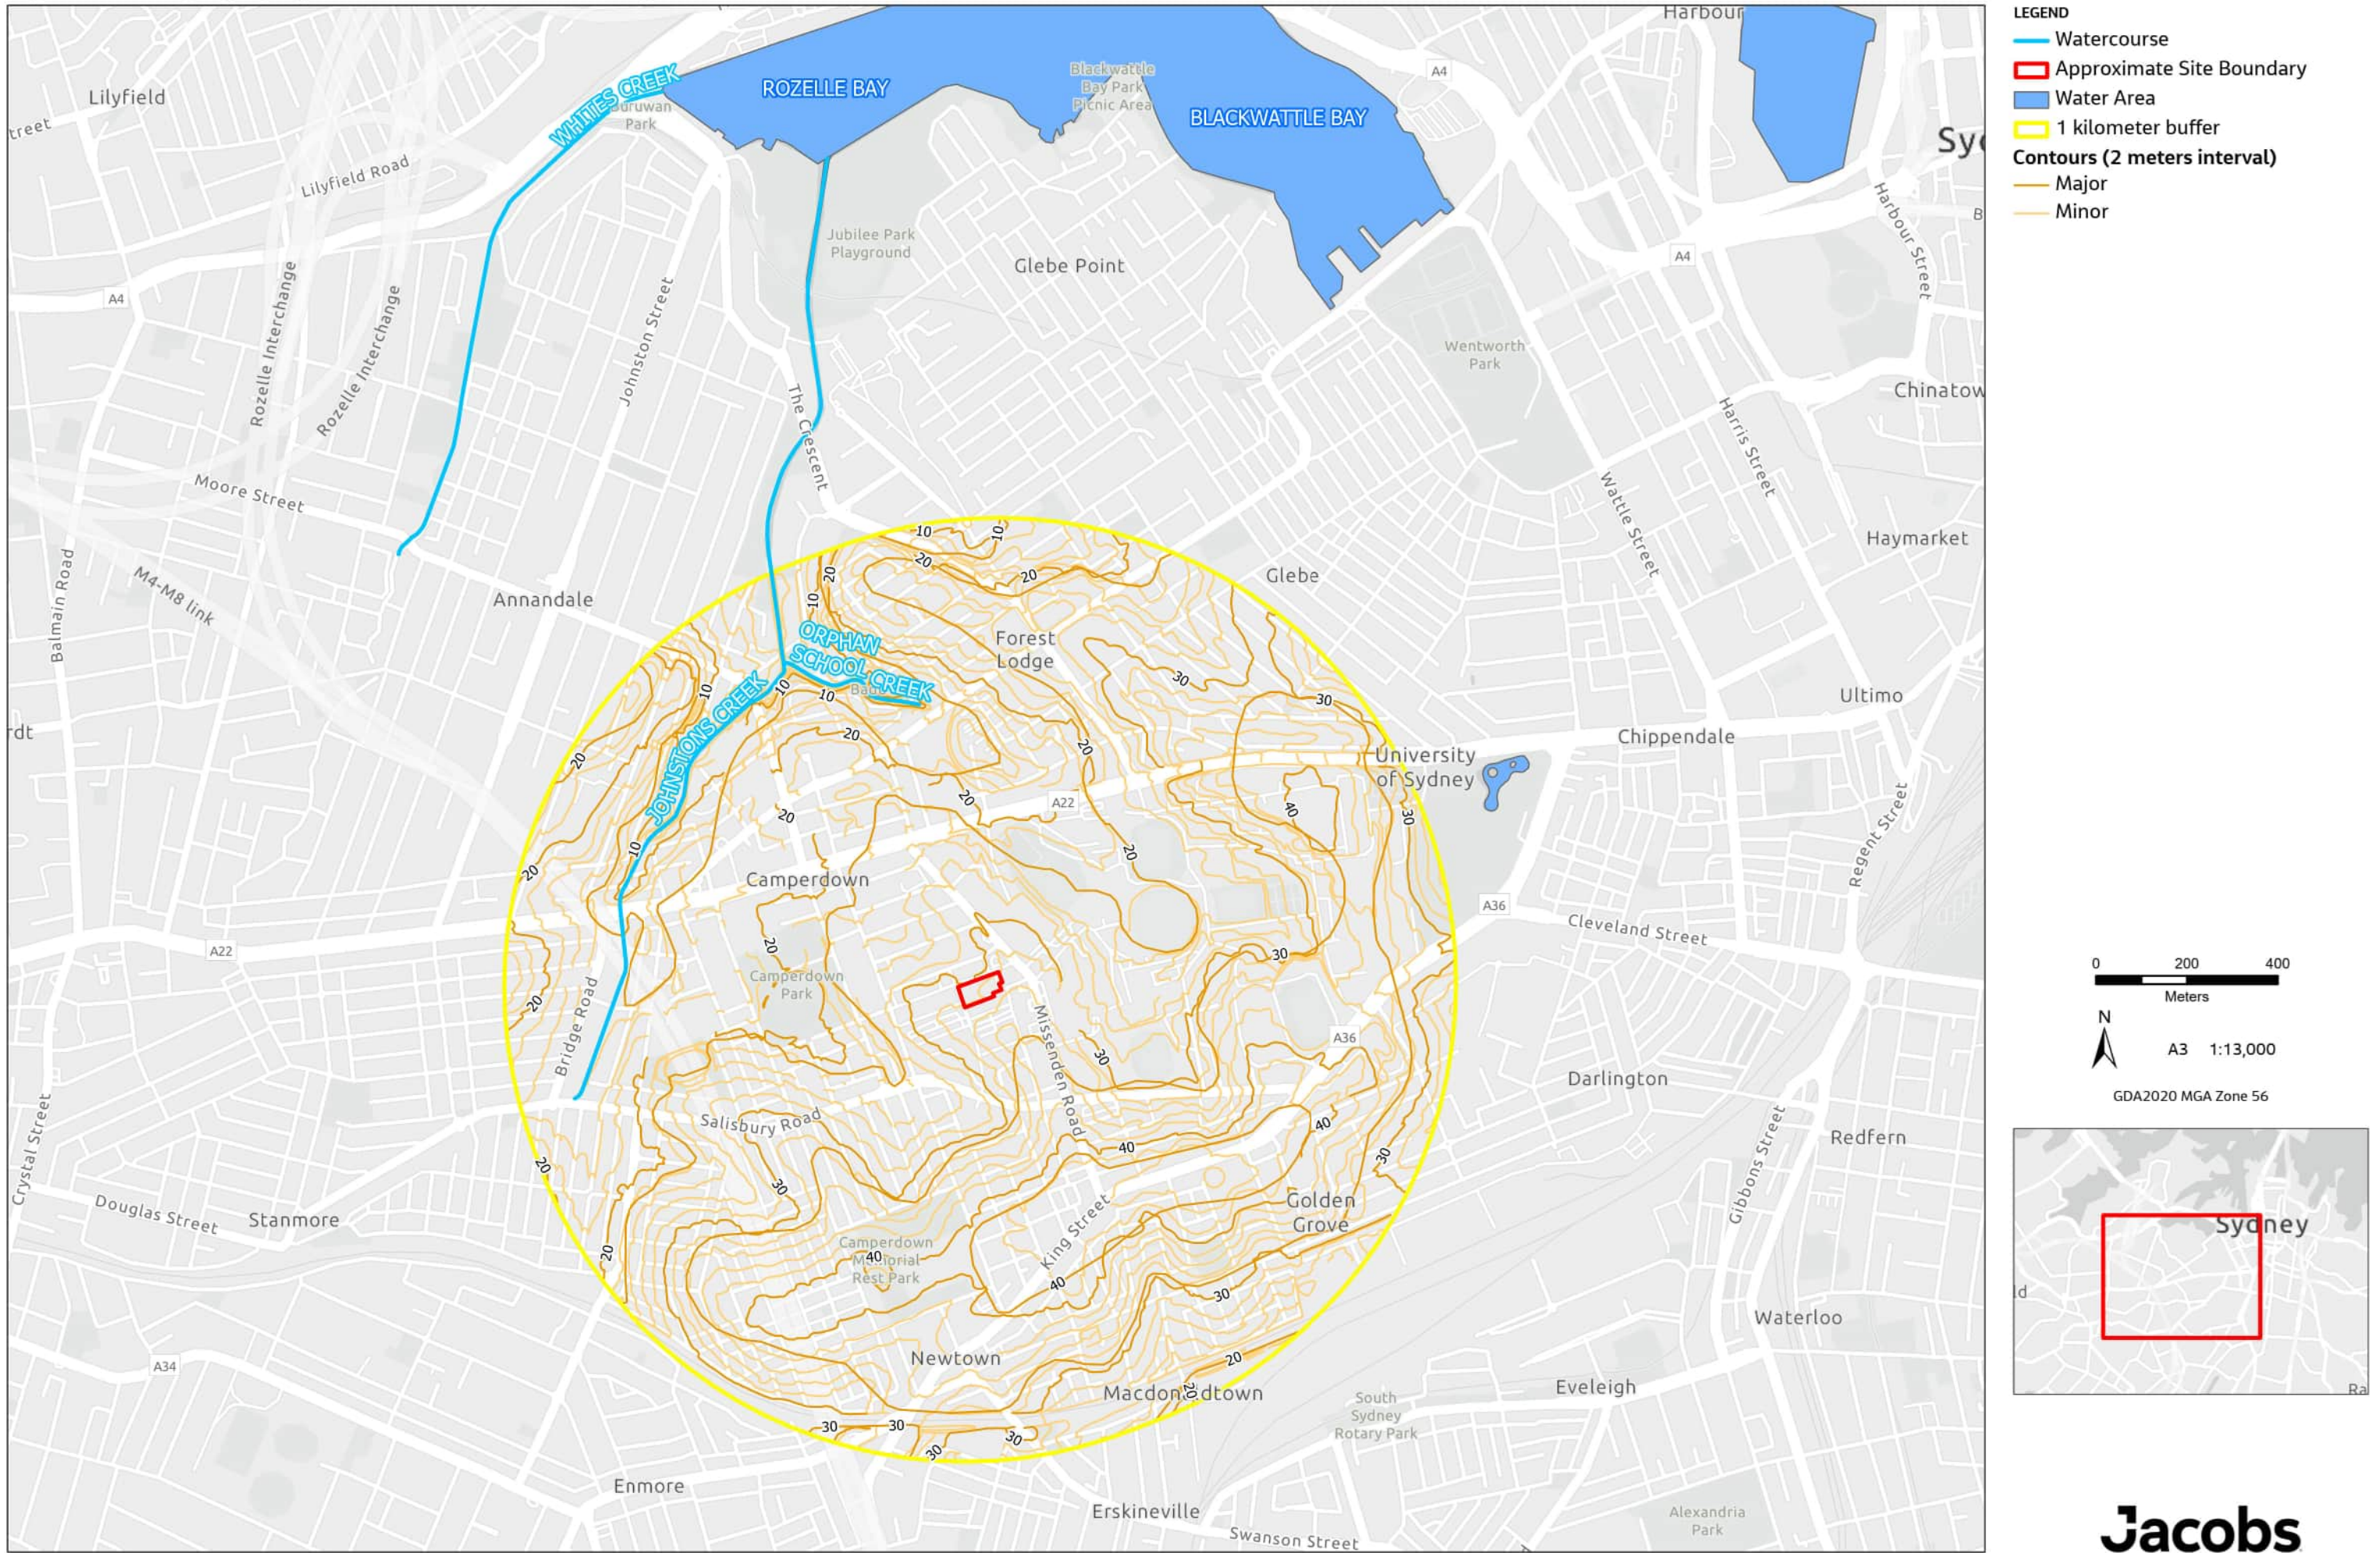
Figure 7: Historical sampling locations

Name	Source	Date	Depth (m)
BH01	GETEX	17/03/2022	2.25
BH02	GETEX	17/03/2022	2.3
BH03	GETEX	17/03/2022	2.7
BH04	GETEX	17/03/2022	5
BH05	GETEX	17/03/2022	2
BH06	GETEX	17/03/2022	2.1
BH07	GETEX	17/03/2022	5
BH08	GETEX	17/03/2022	5
BH09	GETEX	17/03/2022	2.15
BH11	GETEX	17/03/2022	5
BH12	GETEX	17/03/2022	5
BH205	DOUGLAS PARTNERS	13/07/2020	15
BH206	DOUGLAS PARTNERS	14-15/07/2020	17

Boreholes were advanced with a drill rig at 11 external locations surrounding the building on Site (see **Appendix A.7 – Historical sampling locations**). This number of locations complies with the minimum number of sampling points for a site area up to 0.4 Ha set out in the NSW EPA sampling design guidelines (NSW EPA, 2022). However, it is noted that the boreholes were located within the external areas of the Site. No sampling under the Building 81 has been undertaken.

The boreholes were advanced to 2.7 meters below ground level (mbgl) at six locations using push tube and to 5 mbgl at the remaining five locations using a solid flight auger. It is noted that the basement of Building 81 has a floor level of 29.45 m AHD (ANSTO, 2019) which is approximately 1.5 – 2.5 m below the external ground surface around the building (Mitchell Land Surveyors, 2022). Therefore, the boreholes were advanced to, and in some cases deeper than, the depth of the basement floor of Building 81.

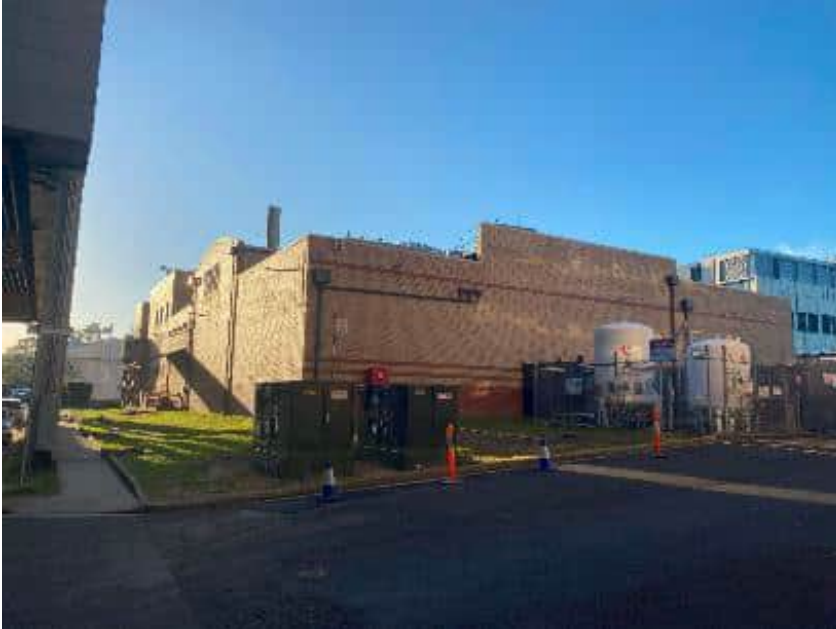
**Photograph 1:** A view of the western and northern side Building 81, NRCF (the Site) across Hospital Road. The Site features two pressurised aboveground storage tanks (ASTs) containing liquid nitrogen and two electrical utility enclosures at the southwestern corner of the building. The ASTs are for an adjacent property and not used by ANSTO.

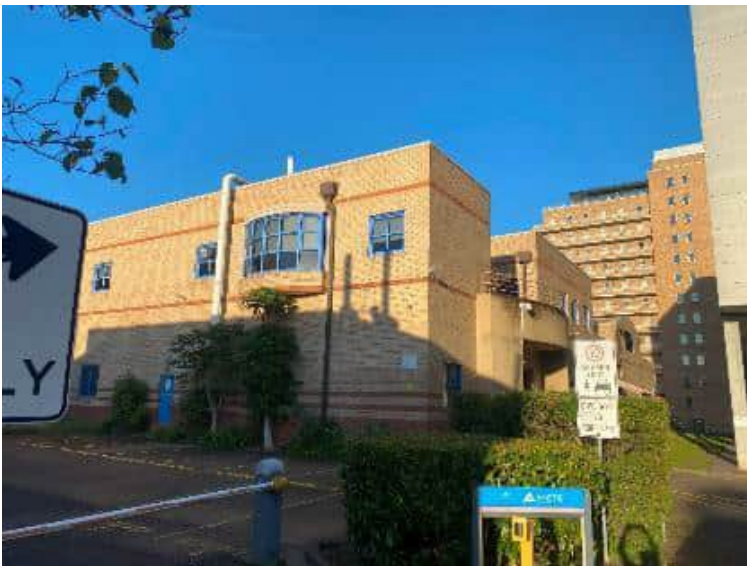
**Photograph 2:** The Site's eastern side as seen from Grose Street. On this side, there are several designated parking slots for NRCF employees.

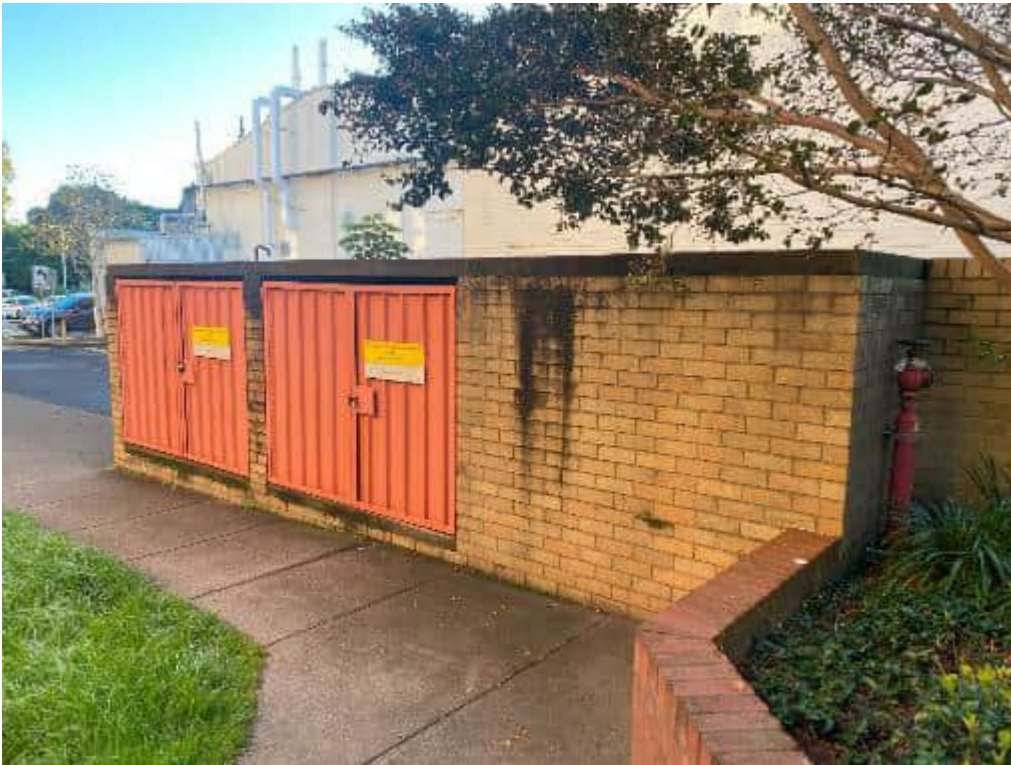
**Photograph 3:** Enclosure for the gas meter (left) and water meter (right) station at the east side of the building. Both doors are secured with padlock and signages posted.

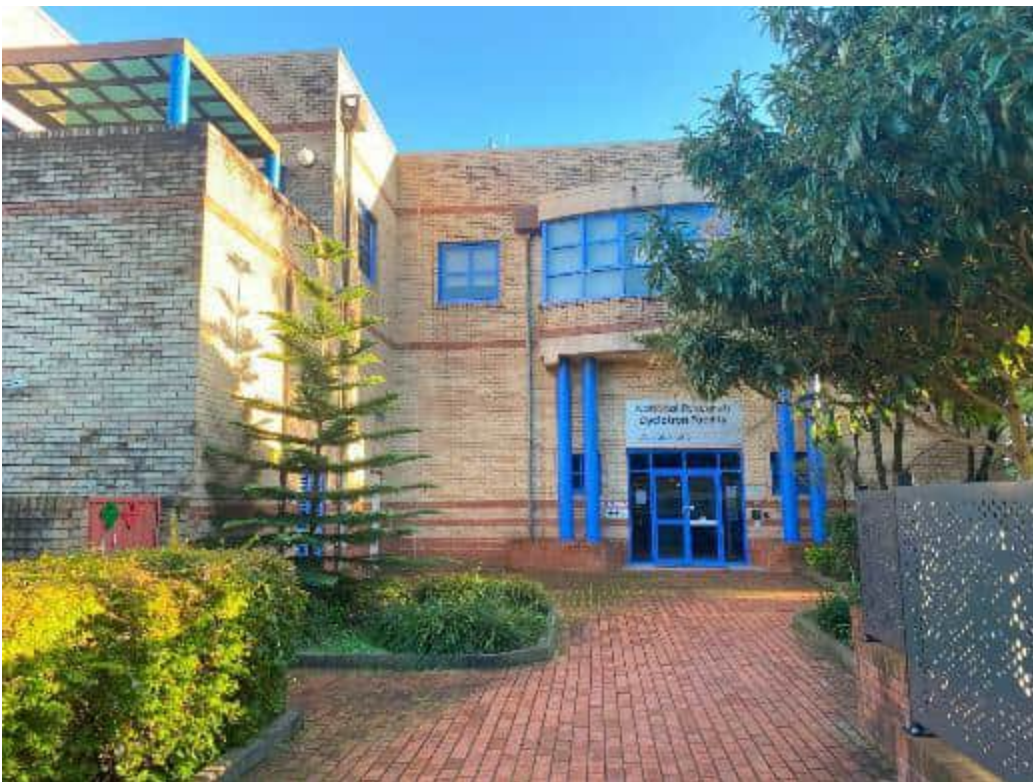
**Photograph 4:** Main entrance of the NRCF at the southeast corner of the building.

**Photo direction:** North

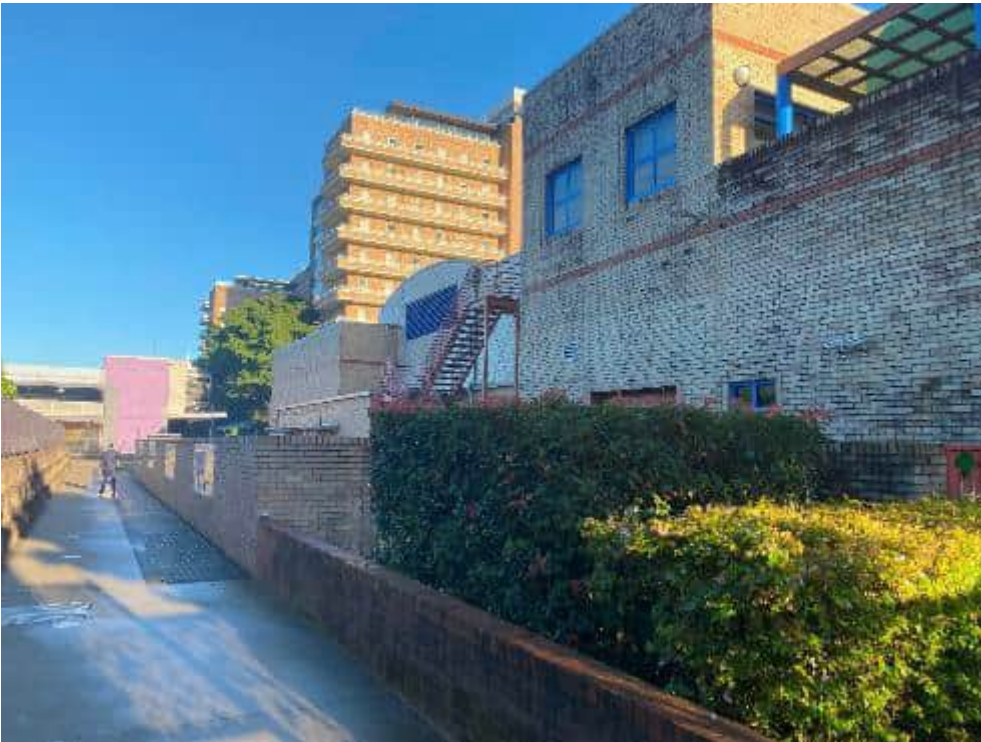
**Photograph 5:** The facade of Building 81. Large steel grates (drainage) fronting the brick fence.  
**Photo direction:** West

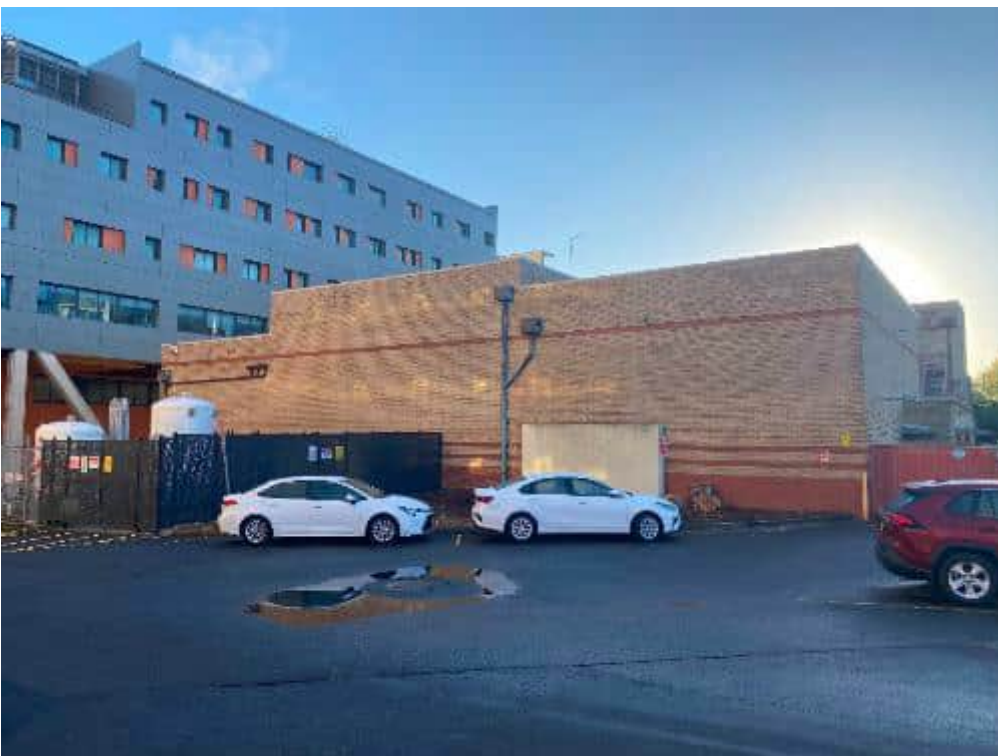
**Photograph 6:** The western side of Building 81. The taller building on the left is RPA Hospital's Professor Marie Bashir Centre. Water observed pooling near the sewer cover.  
**Photo direction:** Northeast

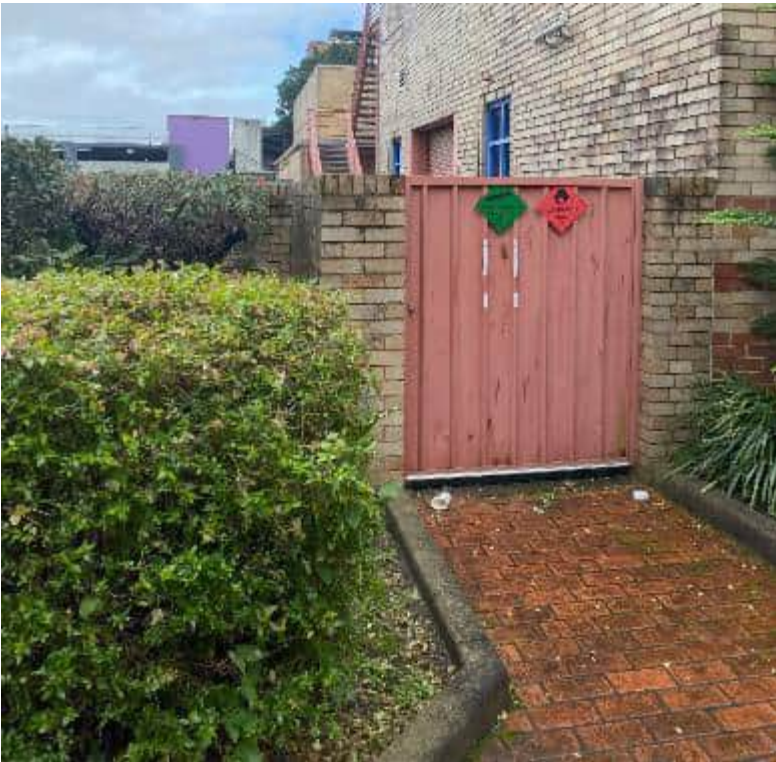
**Photograph 7:** An access steel door at the southeastern corner going to the fenced area south of the building. Signages of flammable gas and non-flammable, non-toxic gas are posted in front of the door.  
**Photo direction:** West

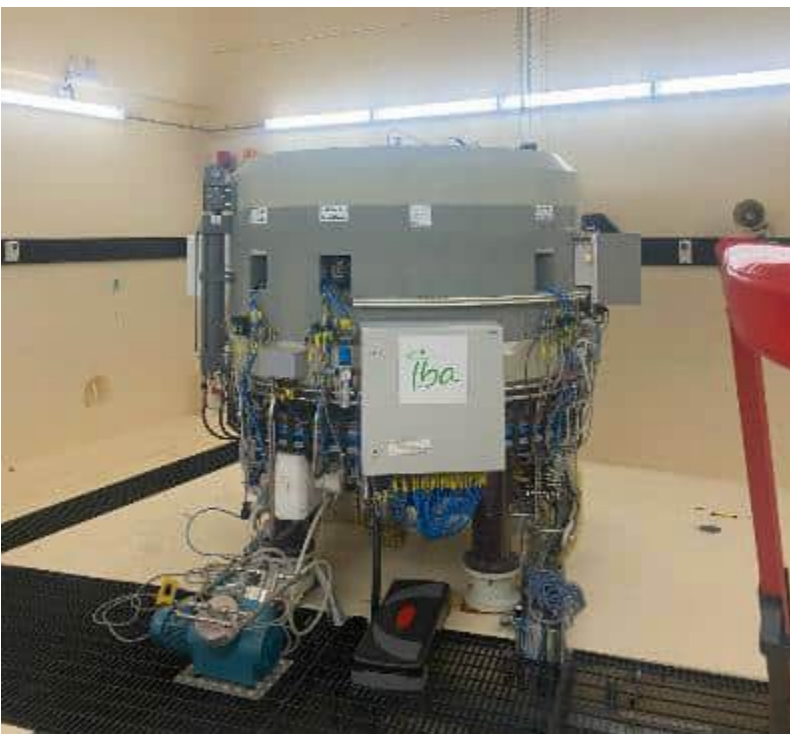
**Photograph 8:** The IBA 18MeV cyclotron housed in Room 0053.  
**Photo direction:** North

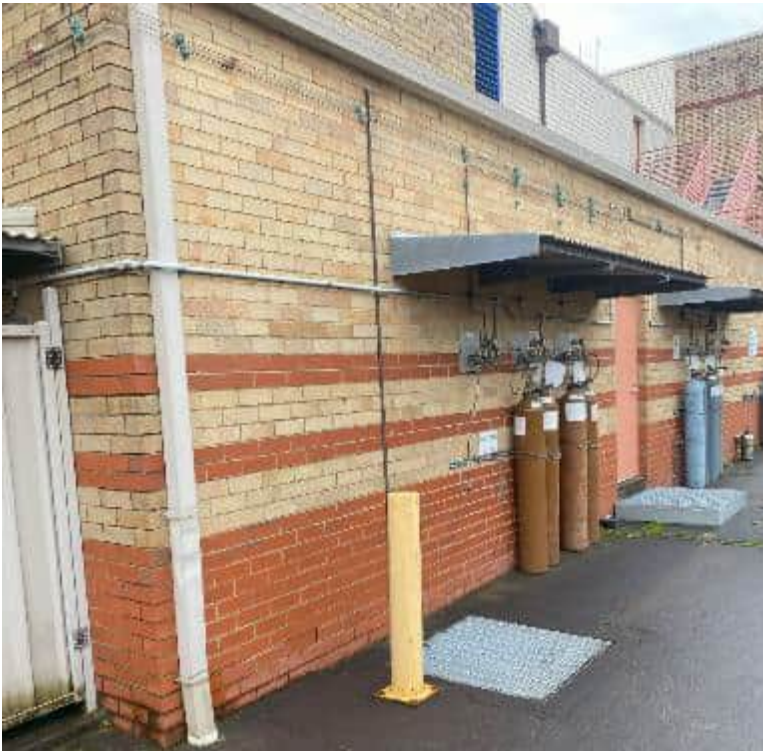
**Photograph 9:** Flammable and non-flammable gas cylinders secured in chains inside the fenced area at the south side of the building.

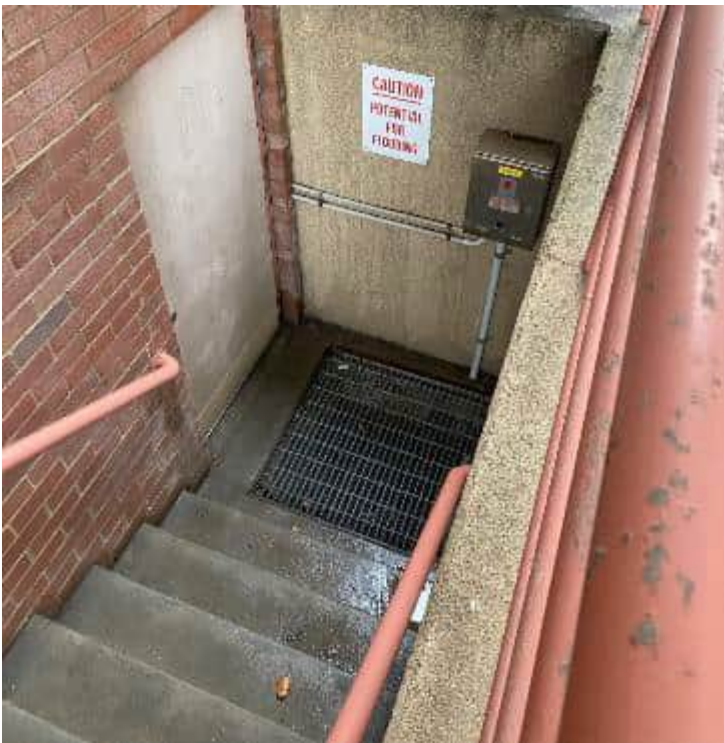
During the Site walkover, ANSTO representatives advised Jacobs that the basement at the Site had been historically subject to surface water ingress during large storm events. A sump was observed at the bottom of the stairs from the ground level outside the northern façade of the building down to the basement. It is understood that water from the sump is pumped to the stormwater network to restrict ingress.

**Photograph 10:** Stairs leading to the basement of Building 81. A large steel grate is located at the landing area and a signage that cautions about the potential for flooding. The steel grate is for a sump to pump out stormwater.

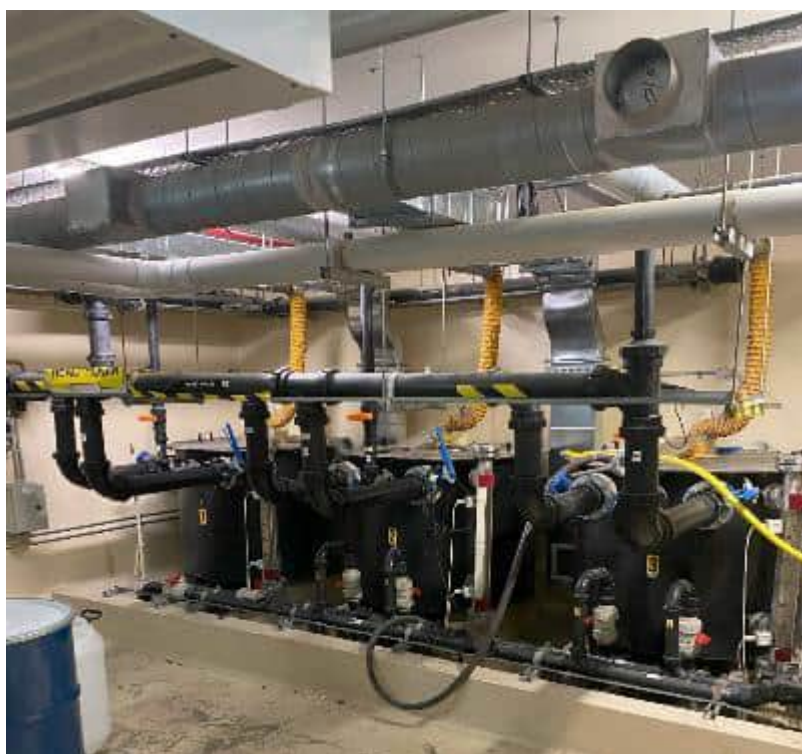
There is a liquid trade waste storage system located in the basement. This consists of three bunded above ground storage tanks used to collect wastewater from basins in the ground floor laboratories where handling of isotopes and associated materials could have caused radionuclide contamination of the wastewater. Water

**Photograph 11:** Bunded trade waste collection system located at the basement.

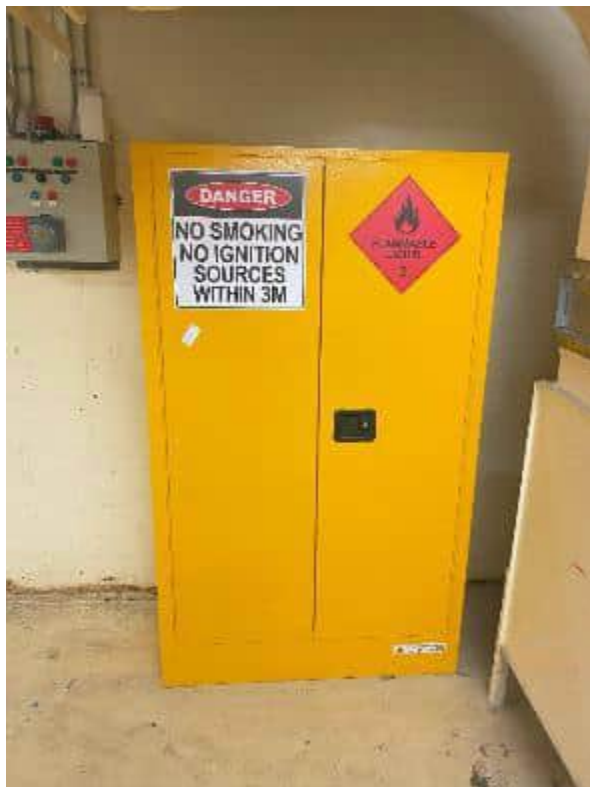
The basement is used for storage of materials including waste. During the Site walkover, small quantities of flammable and corrosive products for laboratory purposes were observed to be stored in dangerous goods storage cabinets. No bulk storage of chemicals (apart from the diesel AST described above) was identified in the desktop review or Site walkover. **Appendix A.4 – Basement floor plan** shows the basement's layout.

**Photograph 12:** A cabinet used for storing flammable chemicals observed at the basement of the building.

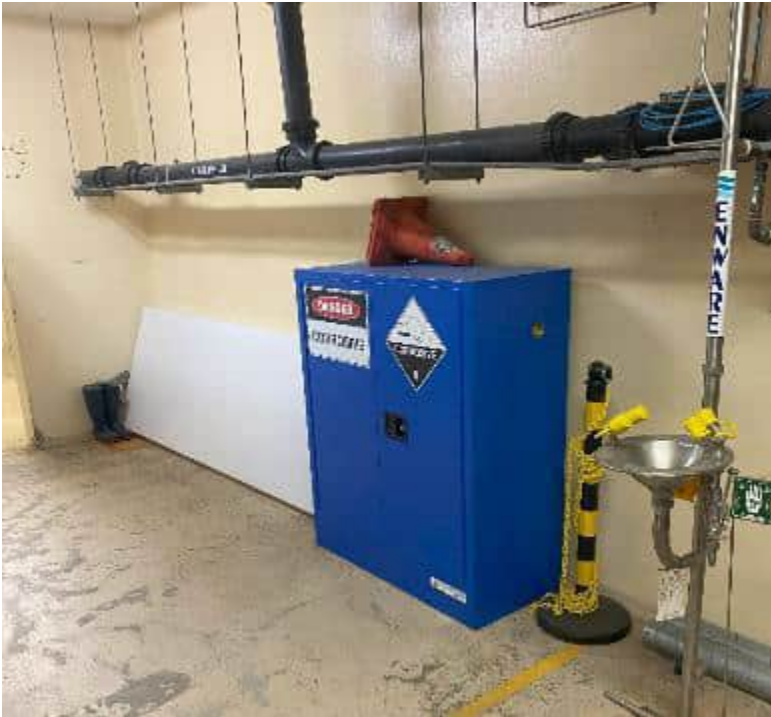
**Photograph 13:** A chemicals cabinet for corrosive chemicals at the basement of the building. An eye washing station is adjacent to the cabinet in case of emergency.

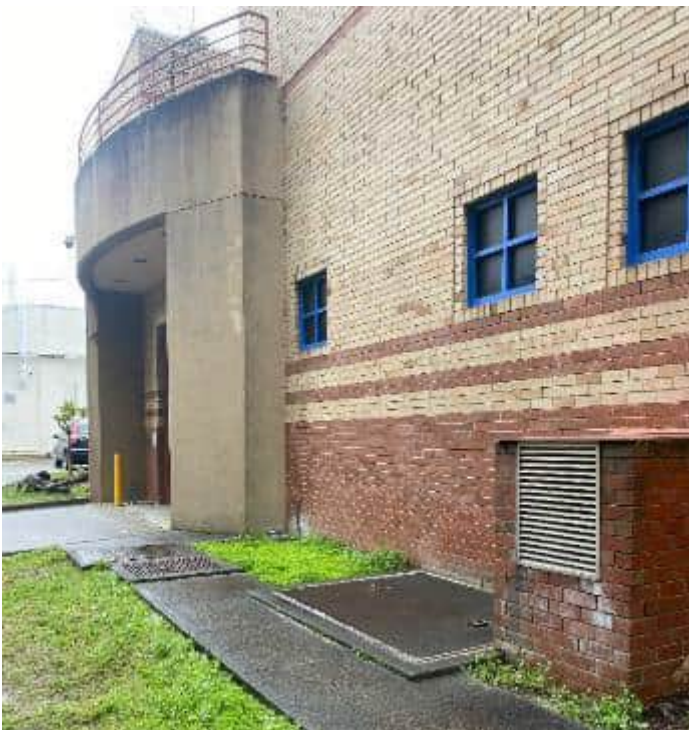
**Photograph 14:** Drainage steel cover and steel grates at the northern side of the building. The cover close to the façade is to enable access to the basement for bulky items.

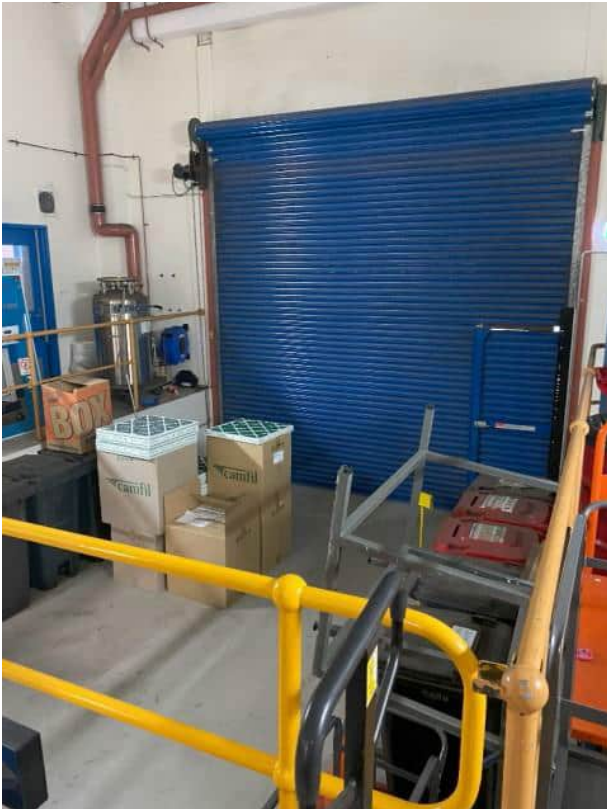
**Photograph 15:** Loading dock on ground floor. A ceiling mounted crane was also present but not shown in the photo.

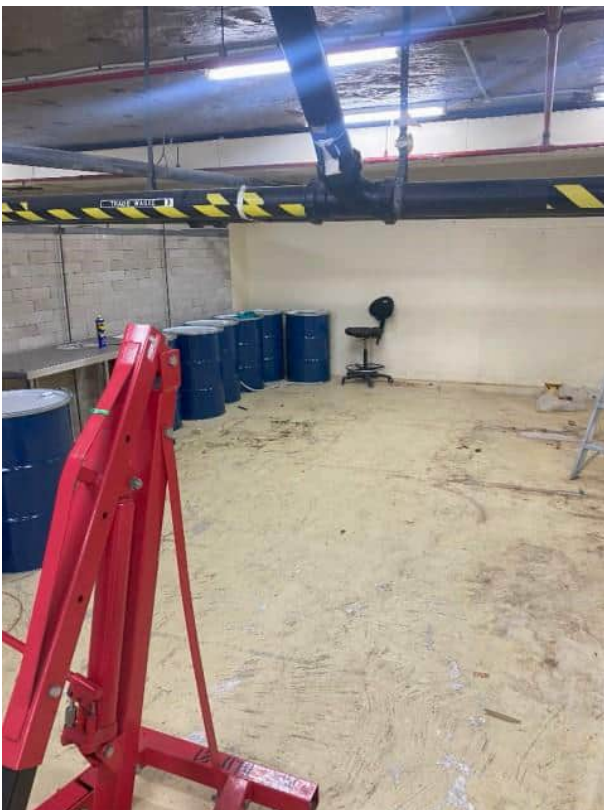
Approximately 20 steel 205 Litre drums were observed in the basement for storage of solid waste consisting of used personal protective equipment.

**Photograph 16:** Example photo of basement floor. Drums are used to store solid waste PPE.

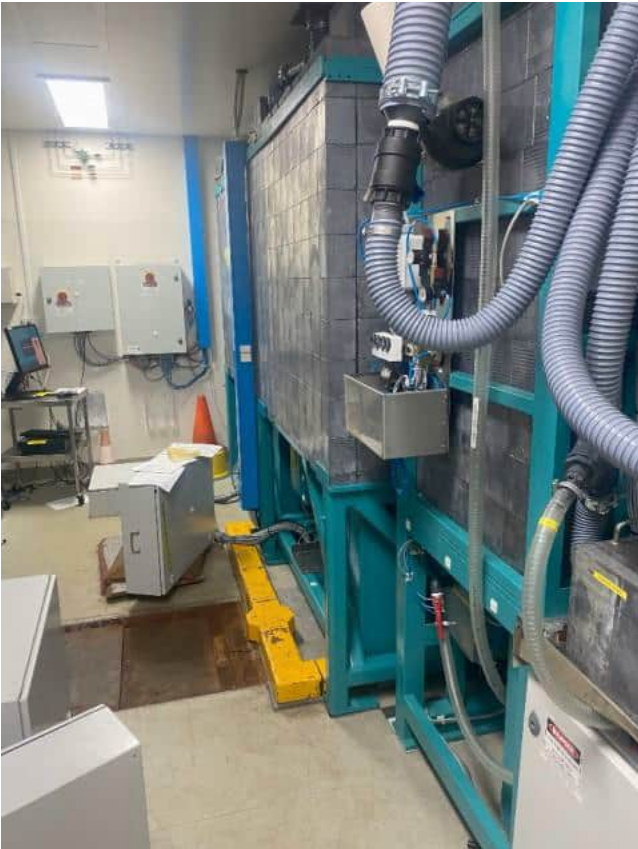
**Photograph 17:** Process unit on ground floor. Lead bricks are used around the unit.  
**Photo direction:** Not applicable

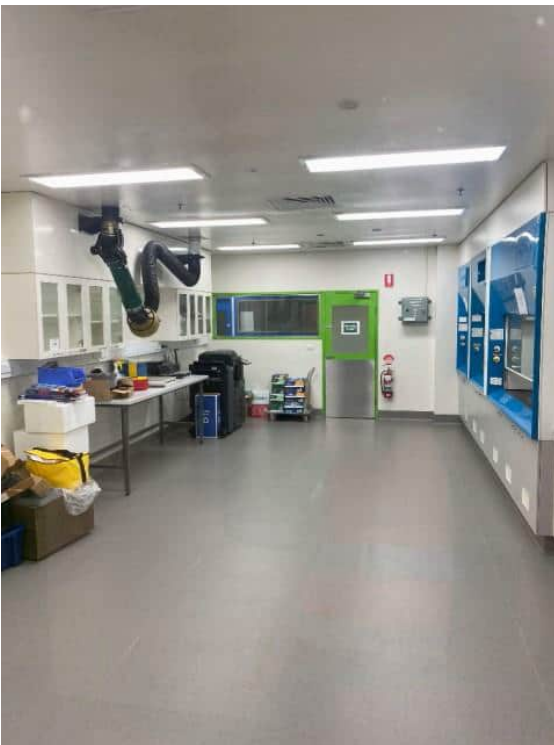
**Photograph 18:** Typical laboratory room on ground floor  
**Photo direction:** Not applicable

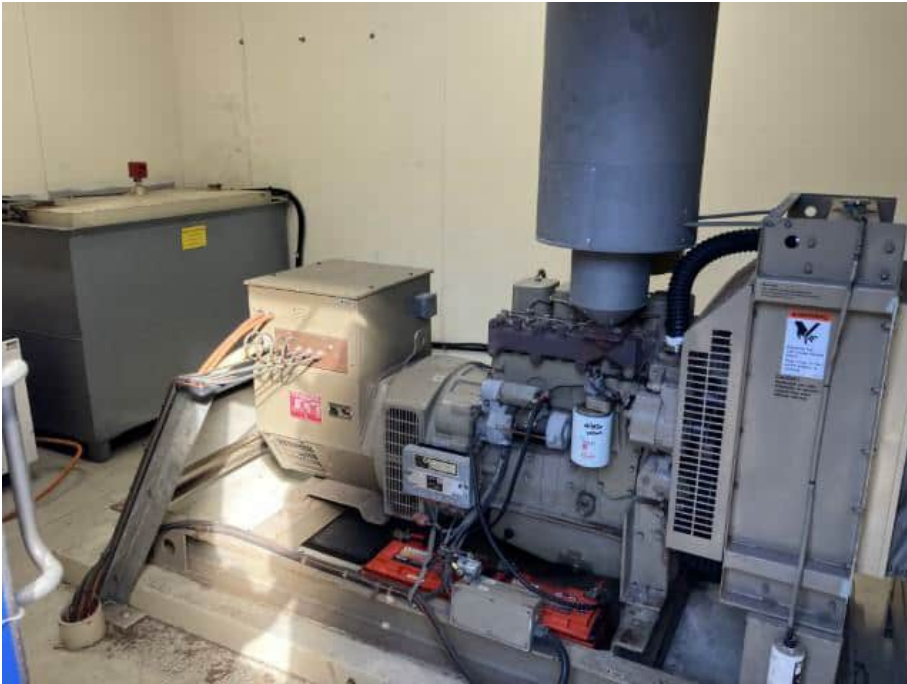
**Photograph 19:** Standby generator on first floor with above ground storage tank in background (photo supplied by ANSTO)  
**Photo direction:** Not applicable

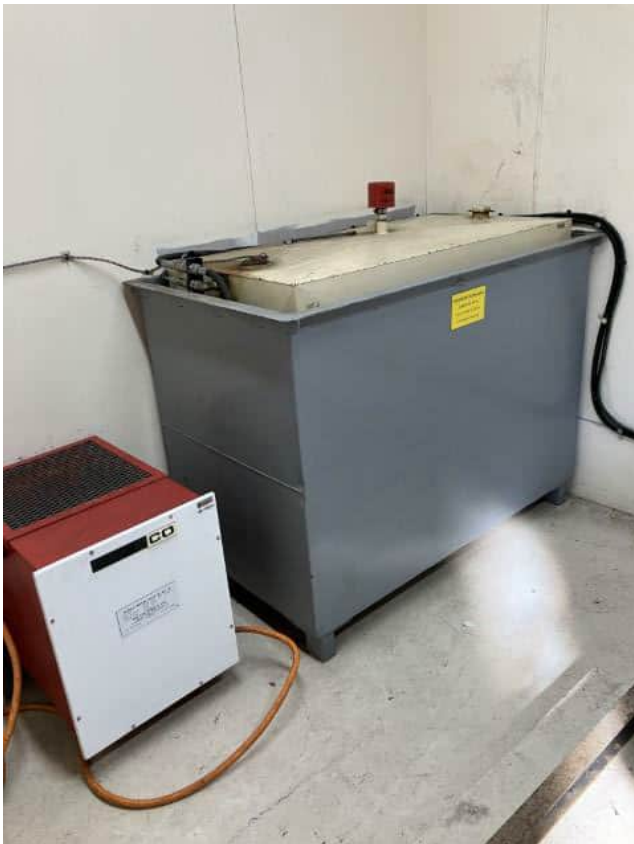
**Photograph 20:** Diesel above ground storage tank for standby generator (photo supplied by ANSTO)  
**Photo direction:** Not applicable
