# Decommissioning of the National Research Cyclotron Facility, Camperdown

Application Number: 01575

1.1 Project details
1.1.1 Project title *
Decommissioning of the National Research Cyclotron Facility, Camperdown
1.1.2 Project industry type *
Commonwealth
1.1.3 Project industry sub-type
1.1.4 Estimated start date *
01/02/2027
1.1.4 Estimated end date *
30/06/2028

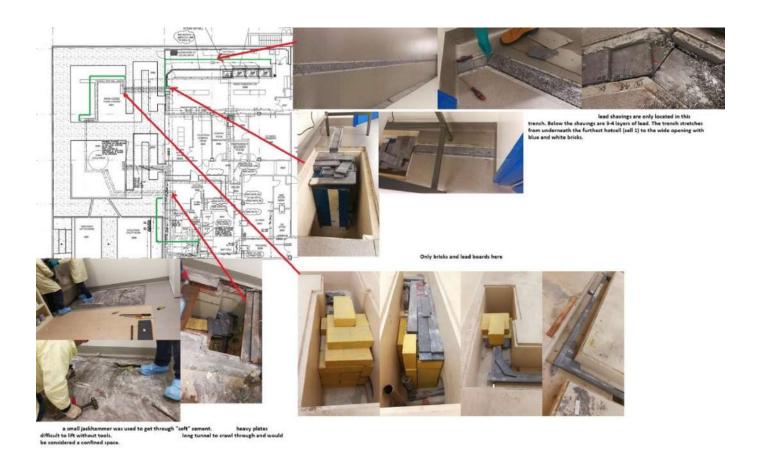
Figure 3 Lead to be removed from trenches

Work will be undertaken on the removal of the lead blocks and shaving with the trenches. The lead blocks and fillings were used to limit radiation dosage exposure to workers working above the ground from the transfer lines running through the trenches (see Figure 3). (The radioisotopes were conveyed to and from the cyclotron to the hot cells via transfer lines).

A specialist lead removalist will be contracted to safely remove and dispose of all lead in the trenches. The removal and disposal of all lead pieces and leads shavings in an efficient and safe manner will occur in accordance with the <u>Risk Management of Lead AG-5542 Act</u>.

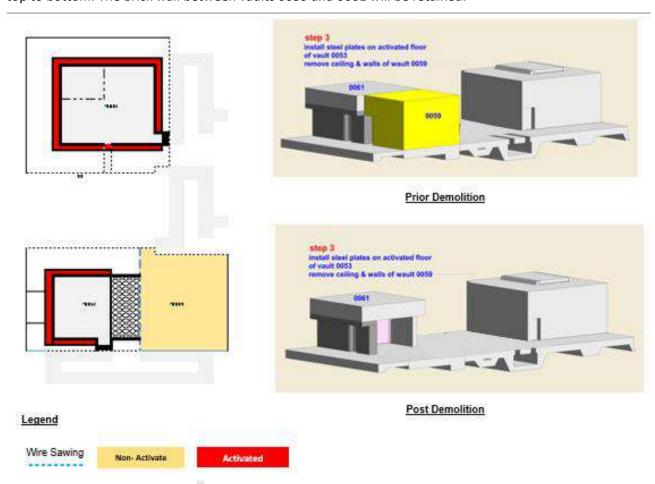
Figure 9 - Step 3 - Demolition of Vault Room No.0059

Prior to any D&D activities, step 3 preparation will involve installing ceiling support in vault 0061. Drill holes will be created in ceiling and walls to provide a precise guide for the wire sawing cut that will separate the ceiling and walls of vault 0059 from 0061. Wire sawing will be carried out from floor level where the machines will be located outside the vault and the cut will include the ceiling and the walls. The demolition of vault 0059, using excavators and breakers, will progress from east to west and from top to bottom. The brick wall between vaults 0059 and 0061 will be retained.

During this step of the demolition, it is expected that 495 Ton of non-activated concrete will be disposed of through recycling facilities.

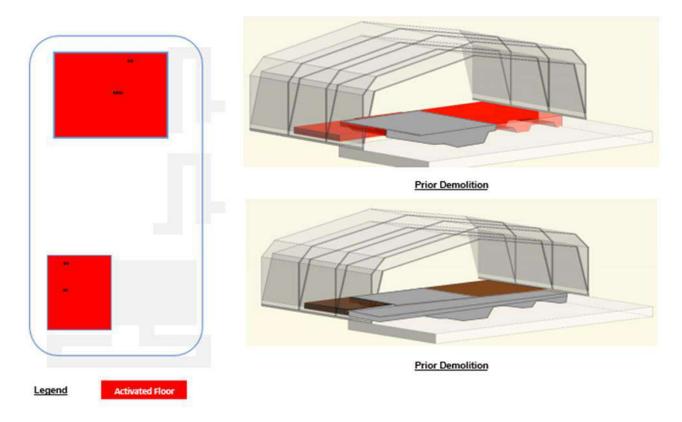
Figure 14 - Step 8 - Removal of Activated Floors in Vault Rooms no. 051 & 061

During demolition, equipment will be located within the non-activated concrete slab in order to minimise the spread of contamination.

Quantities	
Activated Concrete (Ton)	130
Non-activated Concrete (Ton)	0
Total Concrete weight (Ton)	130

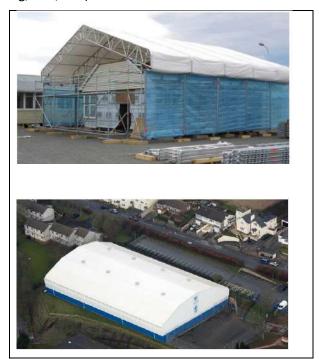
Figure 15 Example of potential enclosure layout and structure

An enclosure will be erected to cover the vault rooms, as well as to allow an area for temporary storage, clearance and loading of the transport vehicles, as shown by the example in Figure 15. The structure will be designed as per AS-1170 and will include considerations for dust containment, prevention of rainwater ingress, and a fire protection system, ensuring protection from external weather events, such as high winds, flooding, rain, etc.).

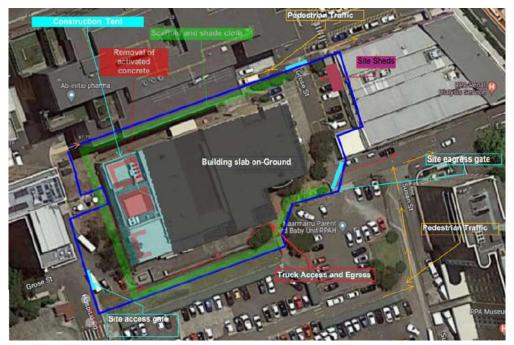
Figure 18 Image of Proposed Truck Access and Egress During D&D Activities

It is estimated that approximately 300 heavy vehicle movement will be undertaken during D&D activities. Therefore, truck access and egress from the site shall be via the southern section of the building to minimise the risk of damage to essential services supporting neighbouring buildings and allow for a smooth flow of traffic. The details of which will be controlled by the demolition contractor as pictured in Figure 18.

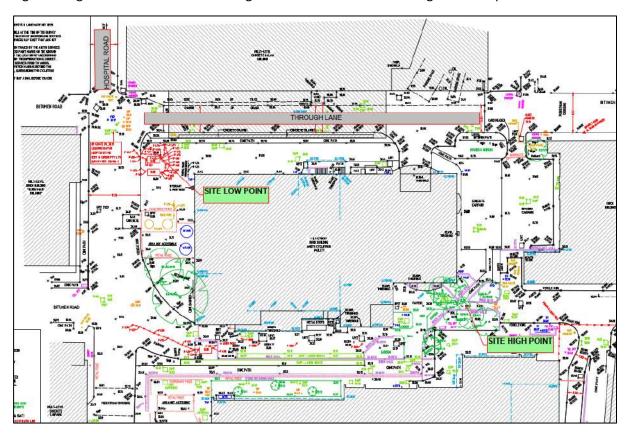
Figure 2.1: Existing Stormwater Infrastructure

A site visit was undertaken on 8 October 2024 to identify the existing site's stormwater drainage strategy and overland flow paths. Upon inspection, the site's topography was predominately grading from east to west, with the high point near the main entry (east) and the low end at the corner of Hospital Rd and the through road of the neighbouring 25 Lucas St site. Refer to Figure 2.1 below for the site's high and low points.

The in-ground stormwater pit and pipe network followed a similar connection strategy. However, almost all inspected pits had varying levels of ponding / trapped water. The degree of ponding within the pits implies a major blockage within the site's network or at the downstream connections into the Council's system. Without access to CCTV footage of the pipes, it is not possible to determine where the blockage is. However, the blockage is likely a combination of the internal site system and the council's network being filled with debris. We recommend jetting and clearing all the stormwater pipes at a minimum. If the blockage persists, a CCTV inspection may be required. Refer to Figure 2.2 below for an example of the degree of ponding within the stormwater pits within dry weather.

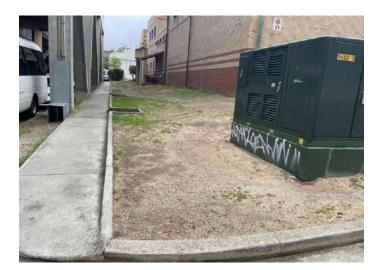
Immediately following the removal of the activated waste from the demolition of ceiling and walls of vault 061, the full depth of the concrete slab will be demolished and removed using excavators and breakers and disposed of in IP1 Bags as restricted waste. The process will be repeated to demolish and the activated slabs in vault room No.0051 (min600mm). Max waste size of 500mm x 500mm. Upon removal of the activated slab, existing soil will be tested for radiological contamination, and contaminated soil will be removed.

The natural low point of the site is at the corner of Hospital Rd and the through road of the neighbouring 25 Lucas St site. Existing electrical substations are also located at this point. Considering sediment and erosion control measures, the proposed above-ground sediment basin is to be positioned near the site's low point to allow gravity drainage of the surface flows from the wider site catchment. The sediment basin is to ensure adequate clearance and no impacts to the below-ground utilities servicing the substation. Refer to Figure 2.4 below for the site's low point.

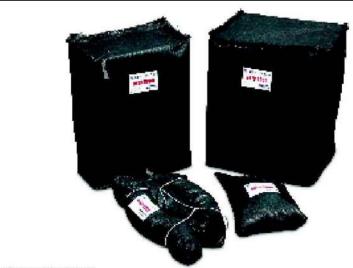
Water Clean FilterBales are a unique new patented 7 stage sediment filter device developed to substantially reduce the migration of sediment and contaminants into drainage systems while allowing filtered water to easily pass through. FilterBales reduce customers time and money by providing solutions to comply witht environmental and regulatory requirements.

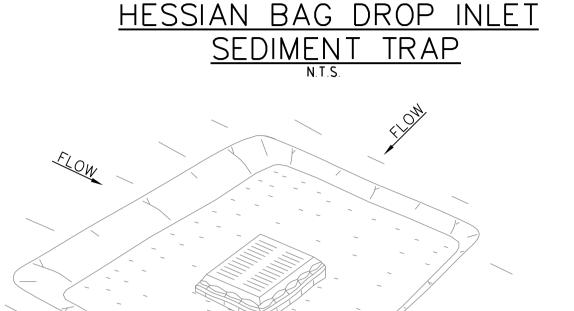
<u>PLAN</u>

-DROP INLET WITH GRATE
